# Anchorage, A Municipal Corporation vs. United States

Assembly Briefing, April 26, 2019

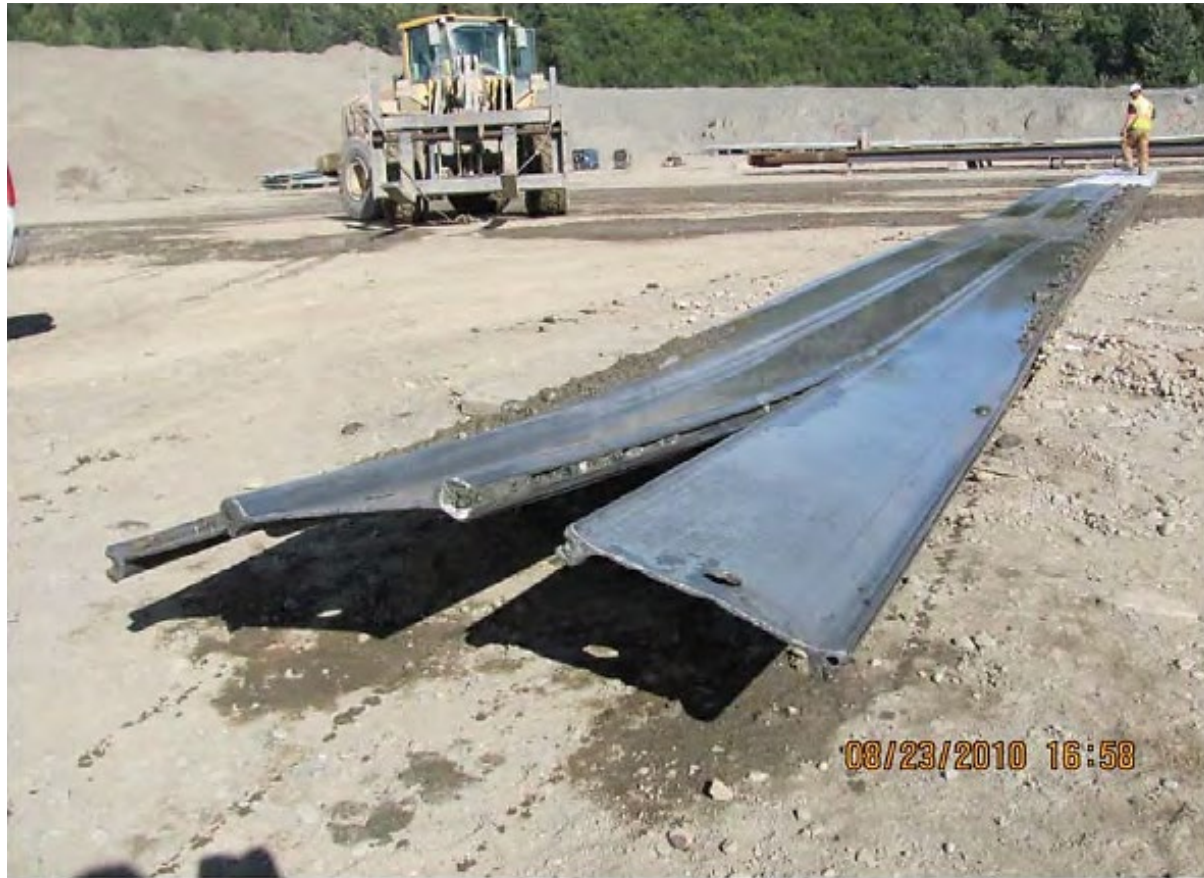
# Example of Unzipped Sheet Pile

Sheet pile “unzipping”

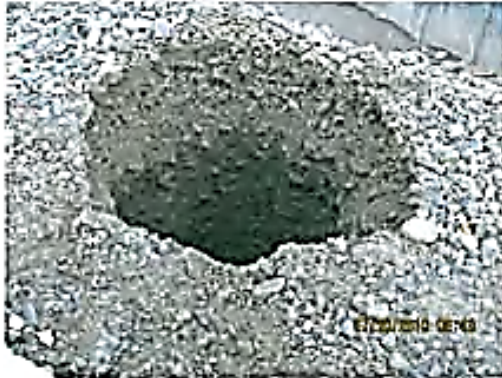
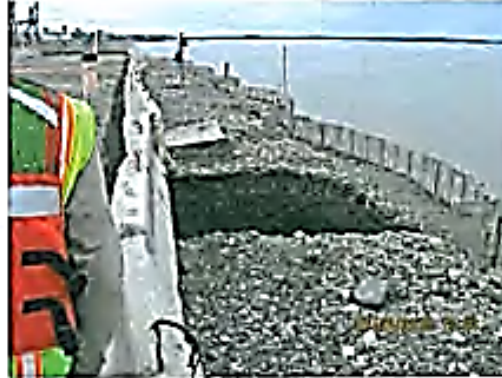
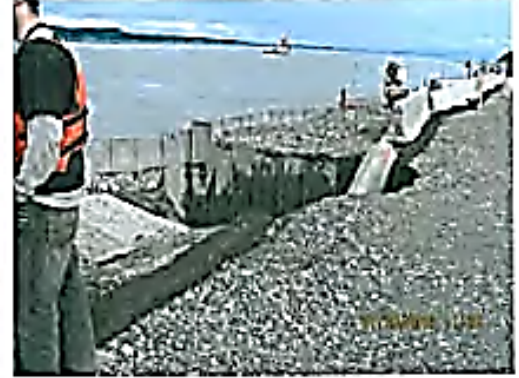
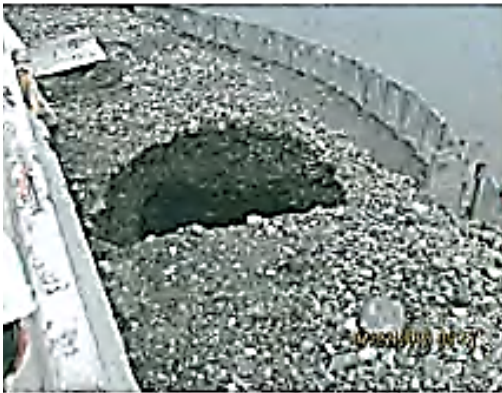
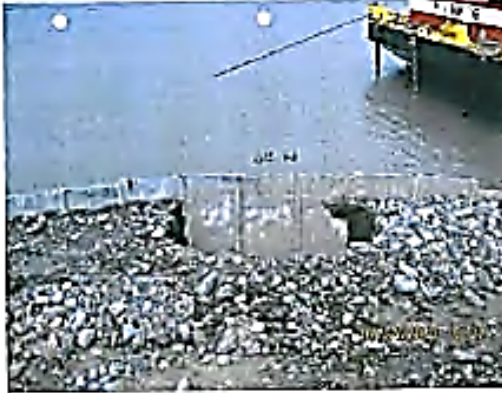
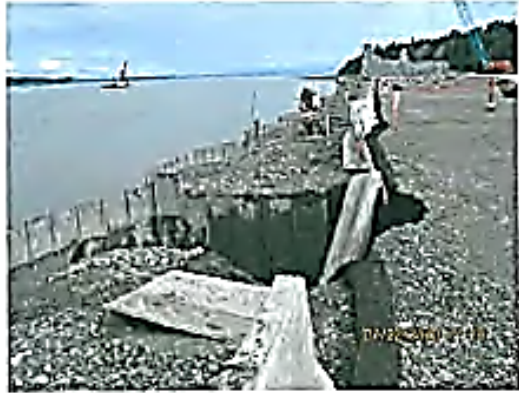
# Sinkholes Resulting from Unzipped Interlocks

**North Extension 2 (NE2).** Only about 800 feet of the NE2 was constructed prior to suspension of construction. The NE2 has had the most dramatic construction defects, consisting of large sinkholes opening behind the sheet piling. The cause of the sinkholes is linked to sheet piles “out-of-interlock” below the water line, creating an opening for saturated backfill to easily pass through the openings. Underwater inspections and forensic explorations have documented the broken interlocks. The FS for static global stability is 1.13, which is significantly below the required FS=1.5.

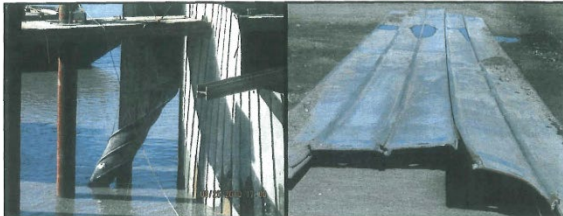
1. At the Wet Barge Berth, damage is present in every cell at face sheets or wyres at WBB cells 27-38. WBB cells 36-38 were removed during August-September 2010 and also found to have tailwall sheet damage.
2. At the North Extension cells 13-30, no damaged face sheets were found. NE cells 9-12, 31 and 32 were removed during August-September 2010 and were found to have face and tailwall sheet damage.
3. At the North Extension cells 41-66, damage is present at multiple cells spread throughout the entire area. NE cells 38-40 were removed during August 2010 and also found to have face and tailwall damage.

Examples of separated interlocks – WBB Cell 36 (left), face sheets pulled from NE Cell 39 (right).
