## **Portland Loo Information Document**

This document was assembled due to the recent number of municipalities requesting information about the Smithers Portland Loo and the Town's experience installing and maintaining it. The document's purpose is to provide general information and lessons learned during and since the installation of the Second Avenue/Main Street Portland Loo.

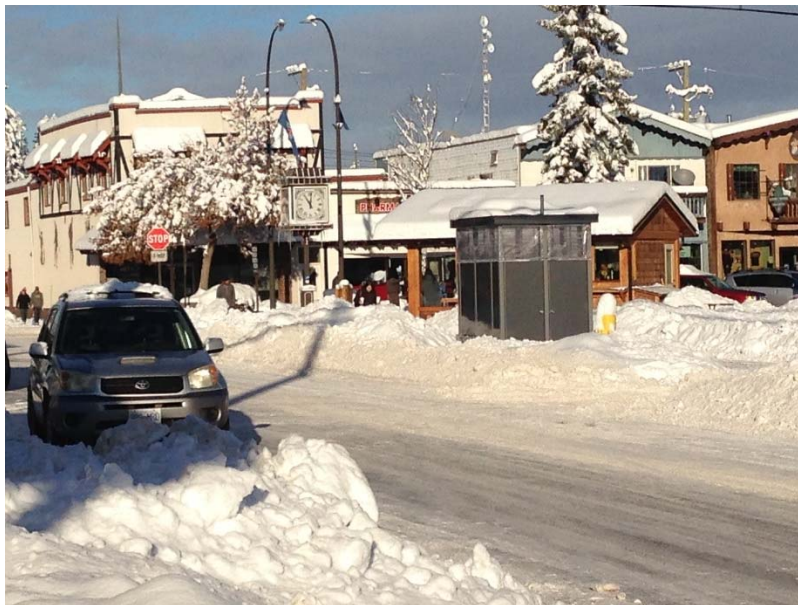
Madden Fabrication will provide the plastic vent cover sheets (see them installed in the photo on page 1) but they had to be ordered separately.

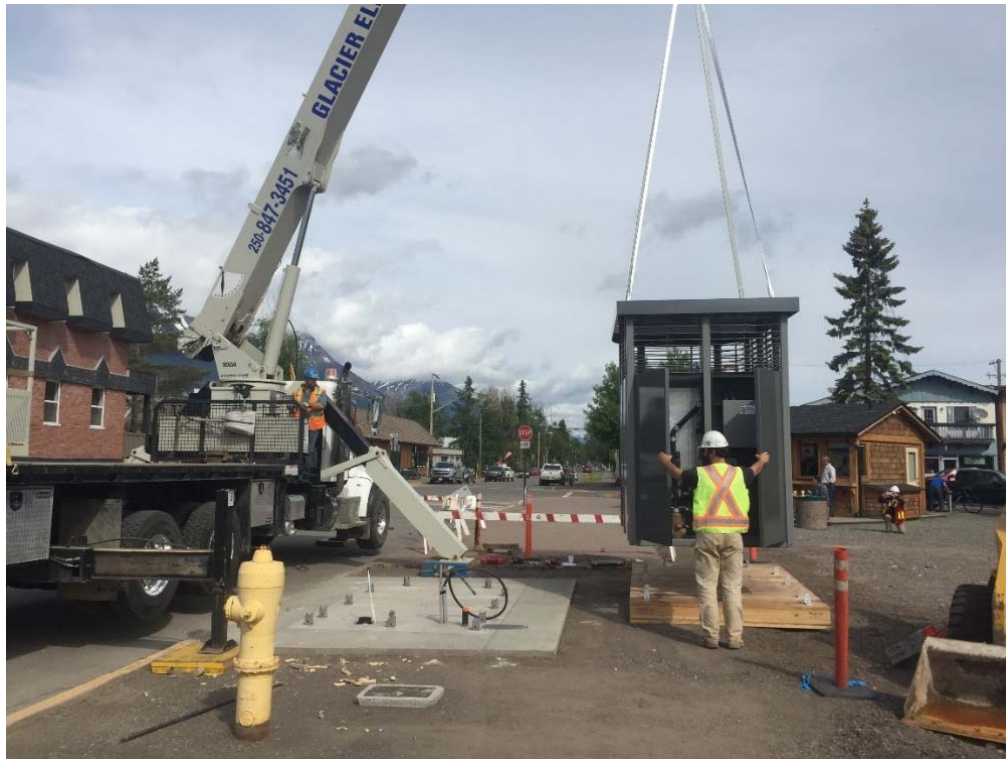
*Installation, July 2017*

Sewer and water connections included excavation and replacement of existing red brick sidewalk and concrete driveway. Electrical connection included excavation and replacement of an asphalt lane and red brick sidewalk. The cost was included in the Canyon Contracting Install contract, (which also included craning and construction of the concrete foundation slab).
